KCF Technolgies Asset Case Studies

Homogenizer Motor

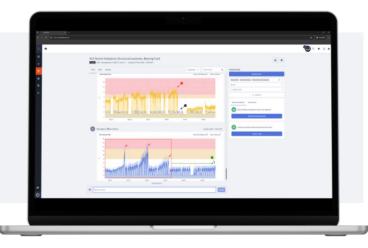
Severe imbalance and structural looseness with a bearing fault (fluting).

Inconsistent operation of the Homogenizer C motor DE bearing, with heightened Peak Accel readings was identified. The main problems were increased vibration and indications of looseness, primarily at the non-drive end compounded with bearing fault frequencies associated with fluting.

A change in sensor position was performed to gather more accurate data. Following continued abnormal readings, the NDR bearing was replaced on August 5, with temporarily reduced the peak accel. Additionally, adjustments to the pulley and belts were made and a soft foot check was conducted. A speed study suggested the opportunity to lower the operating frequency (Hz) of the motor. On August 18, variable frequency drive wiring was replaced due to fluting found in the recently replaced nondrive end bearing. Despite these measures, vibrations continued to rise. This prompted the recommendation to replace the entire motor with one equipped with ceramic bearings to mitigate electrical issues and better manage the operational demands.
