# Municipal Utility District Technical Insights

### Fault Type: Bearing Fault • 40 HP Aeration Blower (Blower 8)

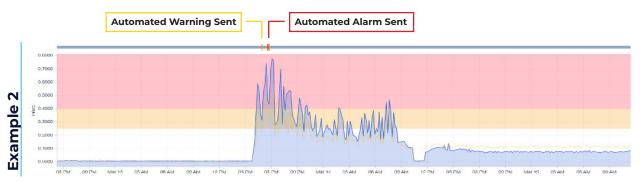
**In another Municipal Utility District,** an urgent alarm was brought to the attention of the maintenance team. Blower 2 of the 75 HP Aeration system, a critical component of the district's infrastructure, was exhibiting troubling signs. The monitoring system, SMARTdiagnostics, developed by KCF Technologies, had picked up on these anomalies.

The primary concern? A fault in the coupling. Vibrations had been steadily increasing, and it wasn't long before they soared past acceptable levels. But it wasn't just the overarching tremors that had technicians worried. A particularly intense 3x vibration spike hinted at a more intricate problem, suggesting a potential misalignment or defect in the coupling.

**Prompt action was essential.** Before any catastrophic failures could ensue, the district's engineers made the call: shut down the asset and address the issue at its root. And that's precisely what they did, opting to replace the coupling altogether, ensuring the longevity of the equipment.

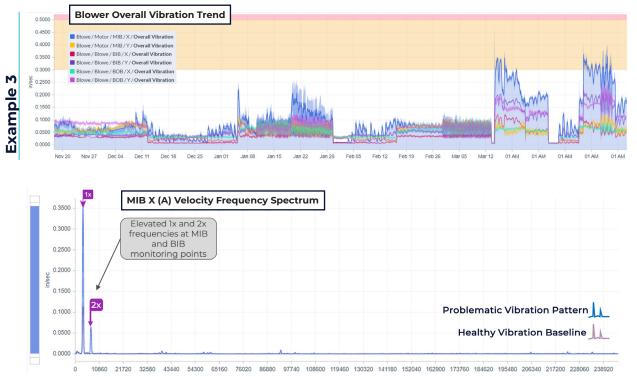
**At a local Municipal Utility District,** Blower 6 of the 40 HP Aeration system began showing troubling signs. As overseen by KCF Technologies SMARTdiagnostics Software, a spike in its usual humming was detected, indicating an anomaly in its smooth operations.

**Two Significant Issues Came to Light:** Problems with the coupling and potential misalignment. The former was evidenced by an overall increase in vibrations when compared to the blower's typical baseline, prompting an automated warning to be dispatched. The latter, misalignment, was suggested by heightened 1x and 2x frequencies, particularly noticeable at the Motor IB and Blower IB monitoring points, known hotspots for such discrepancies.

The blower's vibration trends, spanning several months, painted a clear picture: while there were occasional fluctuations in its vibrations, the recent anomalies were unmistakable. It was a stark reminder of the importance of constant vigilance and the role of timely interventions in preserving vital municipal assets.

vibrations, the district's engineers took immediate action. On inspecting the asset, the faulty coupling was evident. Recognizing the potential risks of prolonged operation with such an issue, a decision was made. They scheduled the blower for an overhaul during the next available downtime, intent on replacing the damaged coupling. This preventive measure would not only save time in potential repairs but also negate the need for an unscheduled maintenance session, should the coupling have failed entirely.

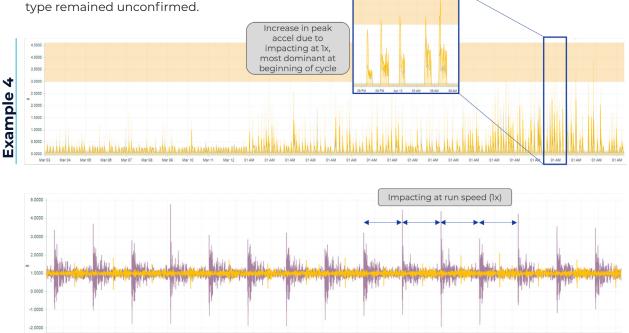
In one Municipal Utility District, the Water Treatment Well Pump was under keen observation by KCF Technologies Machine Health Platform. Distinct anomalies were noted in the pump's operations, even though a concrete fault

- 1. General Process Issue
- 2. Potential Looseness in the Mechanical Components
- **3.** Suspicions of a Mechanical Seal Fault

**The most telling sign** was the sharp rise in peak acceleration, particularly evident when the pump ran at its typical speed. This sudden jolt might imply several things: the aforementioned mechanical looseness, variations in the flow rate, or the potential mechanical seal fault. **Diving deeper into the metrics,** it was observed that the most significant impact of this irregularity was at the start of the operating cycle. The Pump Peak Acceleration Trend showcased these heightened peaks, mainly at the 1x run speed, which was especially pronounced at the cycle's onset.

**However, before jumping to conclusions,** it was paramount to compare this problematic vibration pattern with the known healthy vibration baseline of the pump. The contrast was evident: the fluctuations seen in the recent data were not characteristic of the pump's standard behavior.

It's clear that such anomalies warrant immediate intervention to ensure the continued efficiency and safety of the Water Treatment Well Pump.
