KCF Technologies Asset Case Studies

Lifts

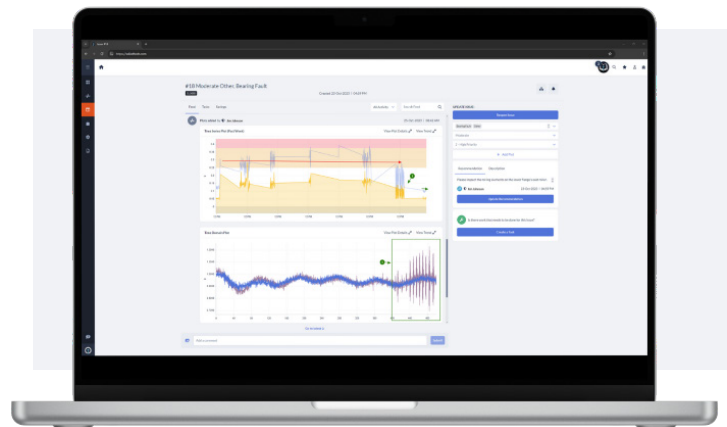
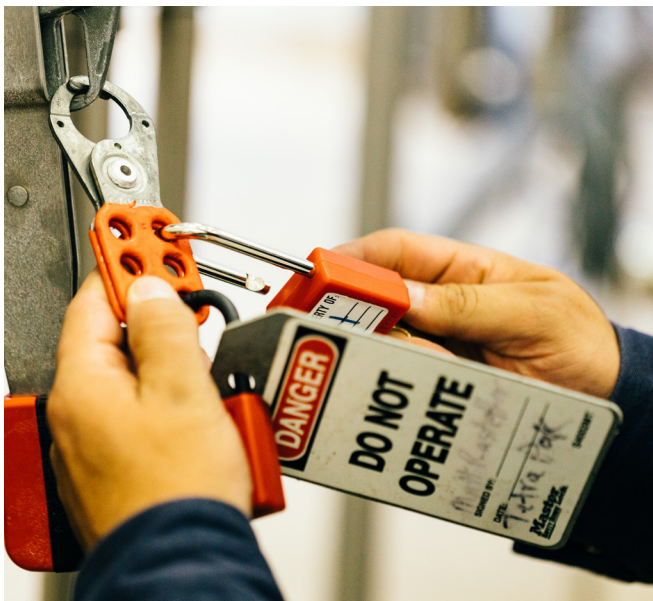
Following install of triggered IoT HUBs, it was noticed that a roller was trending at a significantly higher vibration level than the other rollers on this lifter. A new issue in Desk was opened, highlighting the bearing wear and degradation seen in the data and then notified the plant of the fault.

The maintenance team inspected the bearing and found metal shavings from the worn rolling elements. Within 24 hours, the plant replaced the roller bearing with a new sealed bearing that was already in stock.
